Trajectory Following with a MAV Under Rotor Fault Conditions

Lately, a novel multirotor aerial vehicle capable of handling single rotor failures was presented. When a rotor fails, physically reconfiguring one of the remaining rotors of an hexarotor allows to compensate for maneuverability limitations. In this work, experimental results show the performance of the vehicle in a trajectory-following task in both nominal and fault conditions.

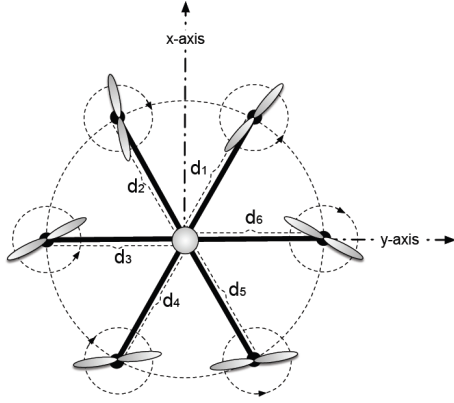
Figure 1: Top view of the proposed vehicle.

When dealing with total rotor failures in hexarotors, it has been proved that a standard hexarotor configuration (one with the rotors spaced evenly in a plane, pointing upwards, with alternated spinning direction, as in Fig. 1) is not fault tolerant in the event of a failure of this type, in the sense of maintaining control over its four degrees of freedom (rotation around its three axis, and vertical speed). One degree of freedom will be lost, being generally the yaw axis the one chosen to be lost control of, as it allows the possibility to land the vehicle safely. From this point on, fault tolerance will be meant in the sense that the system maintains complete altitude and attitude control.

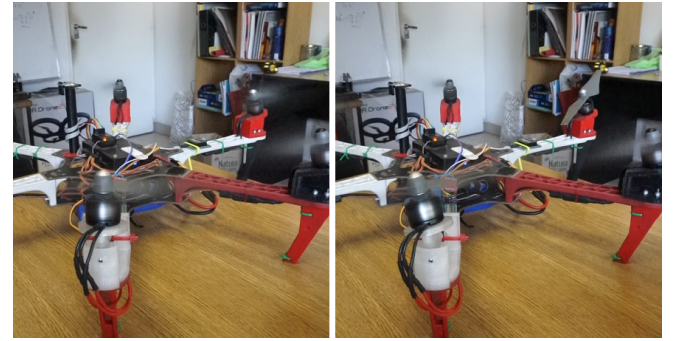
To switch between the different configuration of the rotors for the nominal and failure case, a servomotor is added in rotor 1, that tilts it over the arm's axis at $\delta_1 = 0^\circ$ for the vehicle without failures, and at $\delta_1 = 10^\circ$ in the case of a failure in rotor 3, as shown in Figure 3.

Figure 3: Servomotor in rotor 1 in the case without failure (left) and in the case of a failure in rotor 3 (right).

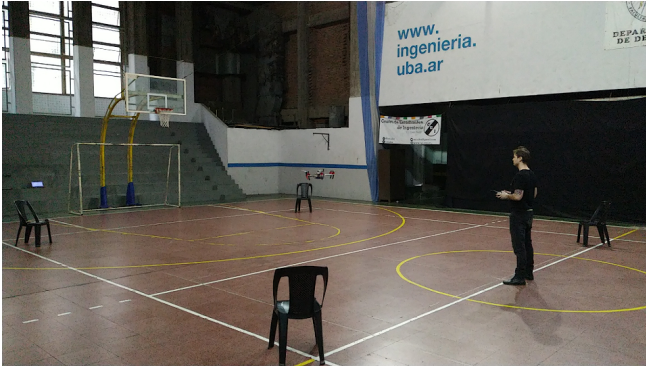
In order to provide position information, an ultrasonic-based indoor navigation system from Marvelmind was used. This system consists of a network of stationary ultrasonic beacons interconnected via radio interface, one mobile beacon installed on the vehicle to be tracked, and one central modem that calculates the position of the mobile beacon. For the experiments, four stationary beacons were placed in a square with a side length of 8m, 40cm above the floor, as shown in Fig. 4.

Figure 4: Environment setup for the experiments. The stationary beacons are placed on chairs at a height of 40cm, in a square of 8x8m.

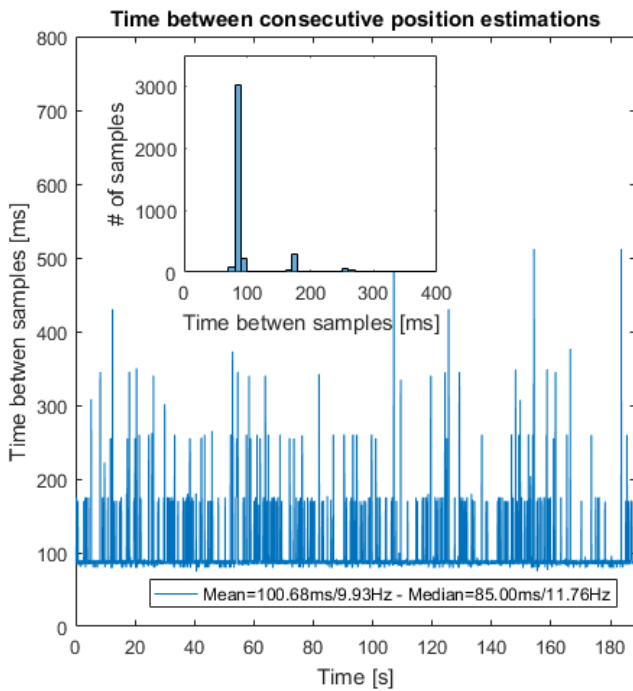
Figure 5: Time between consecutive position estimations from the indoor positioning system, during one of the flights. (Inset) Histogram of the time plot, using 10ms intervals.

The system was configured to provide position estimation at a 12Hz rate, but may not provide data (or provide data with low accuracy) in cases where the line of sight between the mobile beacon and the stationary beacons is obstructed. In Figure 5, the time between consecutive samples of position information (accurate or not) is shown, during one of the flights of the experiments. The data rate of the positioning

system is mostly stable at 85ms (around 12Hz), but it can be observed that there are several occasions where this time is doubled, corresponding to a failure to obtain position information. An inset of axis shows the histogram of the same experiment, where around 90% of the samples correspond to a time interval of $85\text{ms} \pm 10\text{ms}$.

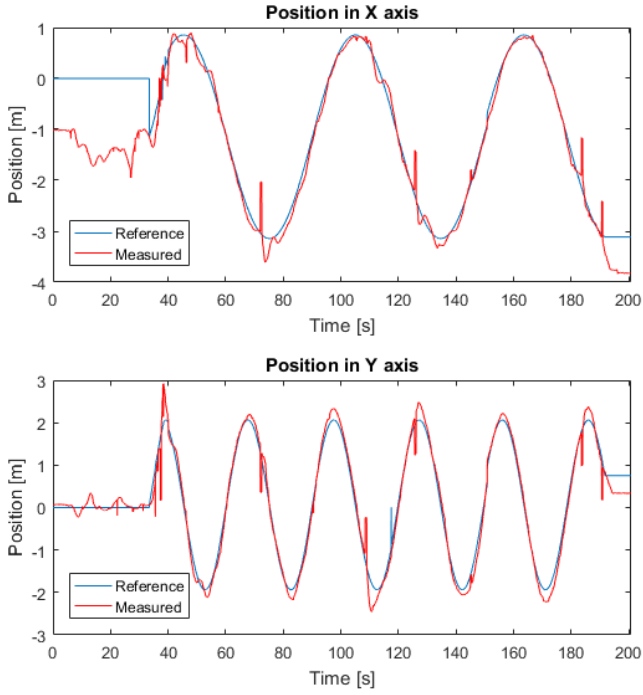
The flight trajectory for the vehicle without failures is shown in Figure 6. The vehicle takes off at $t = 0\text{s}$, and the position control is activated at $t = 33\text{s}$, where the current position is taken as reference. The vehicle performs three and a half full Geron trajectories, before the position control is deactivated at $t = 190\text{s}$, where it lands safely. It can be observed that there are several outliers in the measured position at $t = 72\text{s}$, $t = 109\text{s}$, $t = 126\text{s}$ and $t = 184\text{s}$, that correspond to errors in the position calculation of the Marvelmind tracking system, to which the vehicle reacts accordingly, but recovers quickly and remains on path.

Figure 6: Gerono trajectory for an hexarotor without failure.

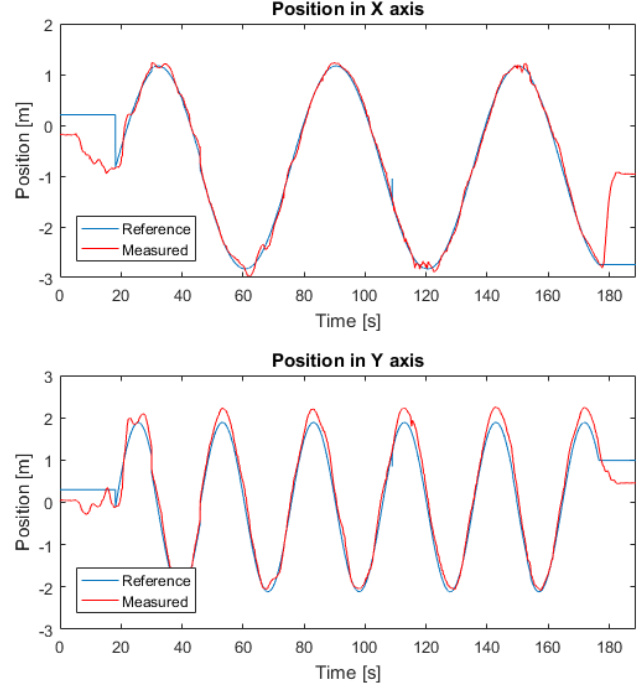
The flight trajectory for the vehicle with a failure in rotor 3 is shown in Figure 8. The failure is activated before take-off, and is present during the full flight. The vehicle takes off at $t = 0\text{s}$, and the position control is activated at $t = 18\text{s}$, where the current position is, again, taken as reference. The vehicle again performs three and a half full Geron trajectories, before the position control is deactivated at $t = 176\text{s}$, and is returned to the take-off point to land. In this test, there were no occurrences of glitches in the position estimation.

It can be noticed that in the Y-axis sinusoidal trajectory, there is some overshoot in the positive direction, while there is no significant overshoot in the negative direction. This is because the rotor in failure state is positioned over the Y axis of the vehicle, and the roll maneuver in one direction seems to be less responsive than in the other.

Figure 8: Gerono trajectory for an hexarotor with a failure in rotor 3.

Still, the failure case shows slight asymmetries in the trajectory, indicating that there are some maneuvers that are performed better than others. This may be caused either by the rotors working at different average speeds, or by the maneuver requiring different speed variations from each rotor.

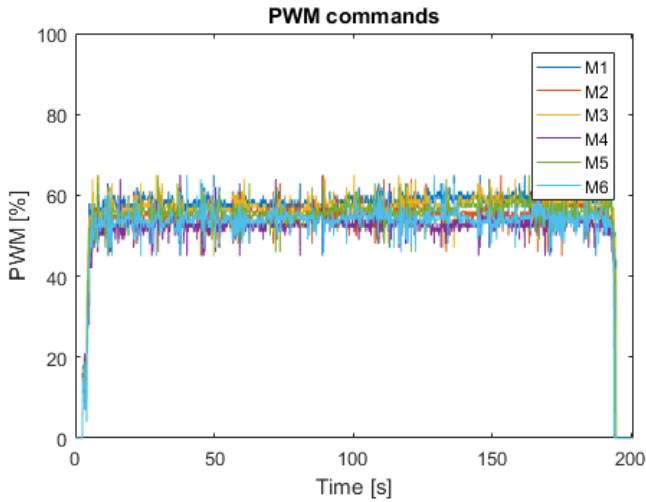
In Figure 7, the PWM values commanded to the six rotors are shown. As expected for a nominal case of a hexarotor in a near-hovering situation, all the PWM values are almost equal, driving the rotors at around 50% of their maximum speed, which provides a wide margin for performing maneuvers without saturating any rotor.

Figure 7: PWM values during the flight without failure

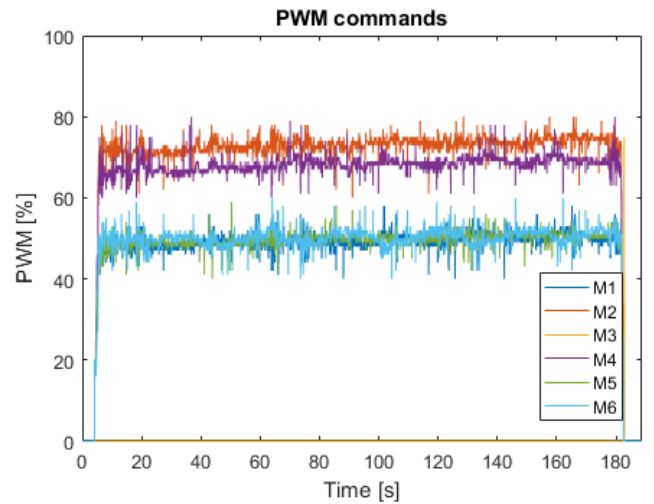
In Figure 9, the PWM values commanded to the six rotors are presented for the case with failure. While the PWM value for rotor 3 is zero during the flight, the commands to the rest of the rotors do not significantly differ for the previous case.

Rotors 2 and 4 increase its speed (and thus its thrust), to compensate for the lack of thrust of the motor located between them. All the maneuvers performed during the trajectory do not require a great variation of speed (the PWM values for all the rotors only vary around $\pm 5\%$). This suggests that the vehicle with failure also is able to perform aggressive maneuvers without saturating the rotors.

Figure 9: PWM values during the flight with a failure in rotor 3.
